**Report 001**

# /condition inspection of 311-CV-1001

scan/report by seth schurman

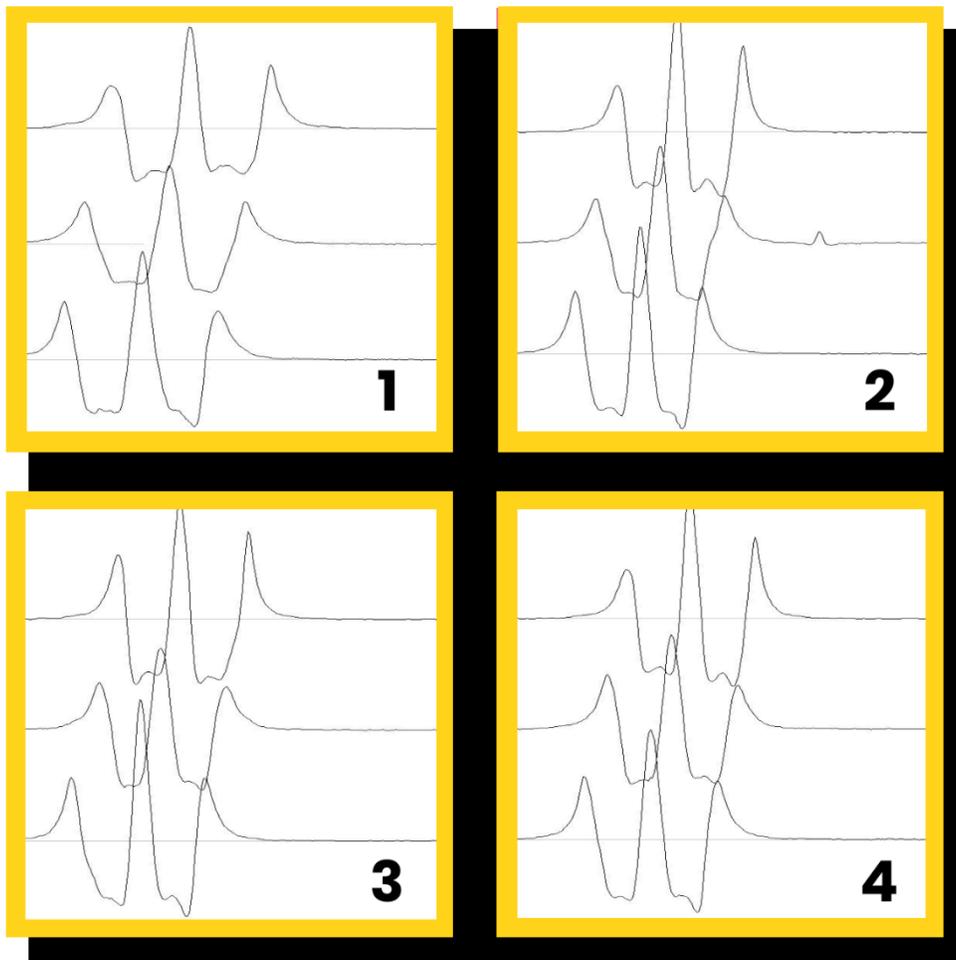
splices 1 - 4

Ten (10) 3-Stage splices were recorded in the data and all splices are estimated to be in average condition at the time of recording.

■ All ten splices are considered to be in average condition with no anomalies to report at the time of testing. This is the first MFL scan to be performed on CV 311 and will be used as a baseline for future scan comparisons.

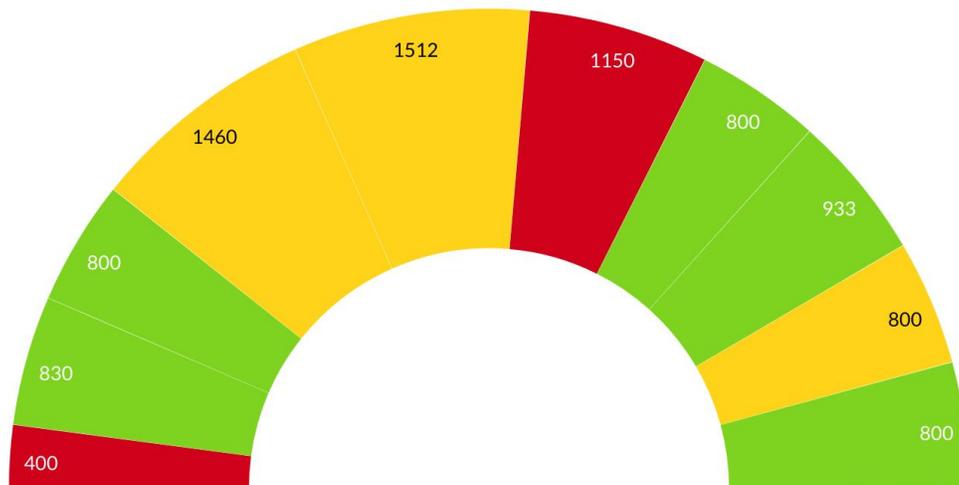
- section 1 (400') (4.22%)
- section 2 (830') (8.75%)
- section 3 (800') (8.43%)
- section 4 (1460') (15.39%)
- section 5 (1512') (15.94%)
- section 6 (1150') (12.12%)
- section 7 (800') (8.43%)
- section 8 (933') (9.84%)
- section 9 (800') (8.43%)
- section 10 (800') (8.43%)

each section of belting is color coded to represent the severity of damages within that section. Colors meaning green being good, yellow being average, and red being below average and in need of immediate attention. Please refer to table of events for location of all larger damages.

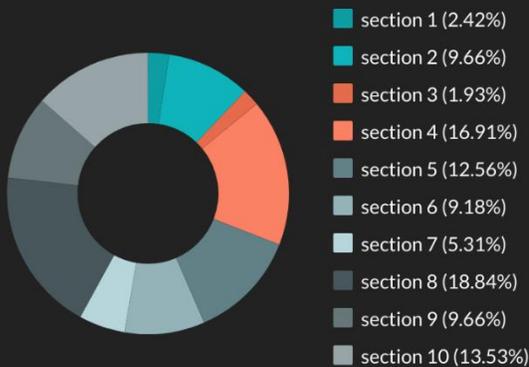
## /belt map

percentages are based on each section of belt's total overall damages
